**Mechanical Behavior
and Fracture Characteristics
of Off-Axis Fiber Composites
I - Experimental Investigation**

John H. Sinclair and Christos C. Chamis

NASA Technical Paper 1081

John H. Sinclair and Christos C. Chamis
Lewis Research Center
Cleveland, Ohio

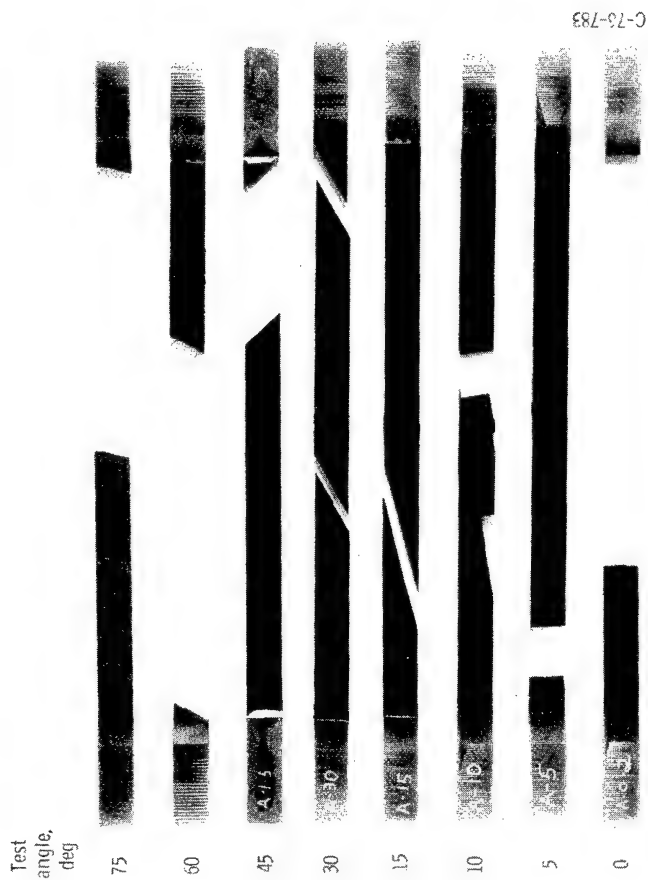
Figure 14. - Fractured test specimens (Mod I/E).

The fractured specimens are shown in figure 14. The fracture of a five-gage instrumented specimen is shown in figure 15. Note in figure 14 that the specimens tested at 0° , 5° , 10° , 15° , and 30° off-axis fractured away from the end tabs and those tested at 45° , 60° , 75° and 90° fractured near the end tab. Fractures occurring at or near end tabs are to be expected. Finite-element analyses results to be discussed in Part II show that the stresses at the edge near the end tab are higher than at the center in certain orientations. Consequently, these stresses can initiate fractures near the end-tab region. This leads to the interpretations that the fracture stresses of specimens that fractured near the end tabs are on the conservative side. Therefore, the axial stress

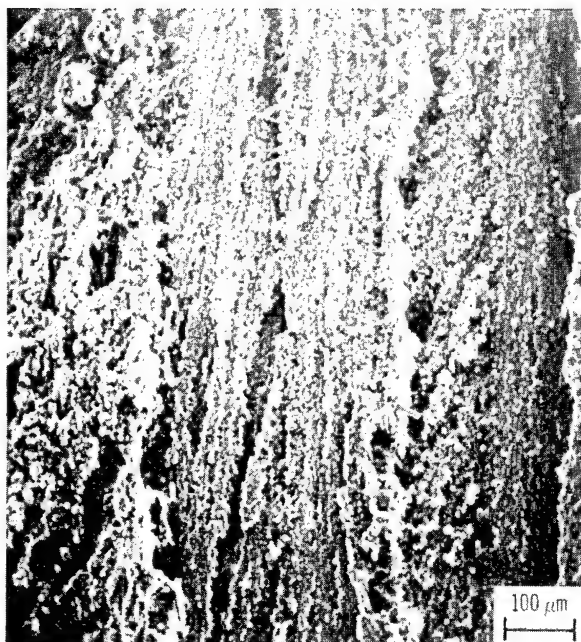
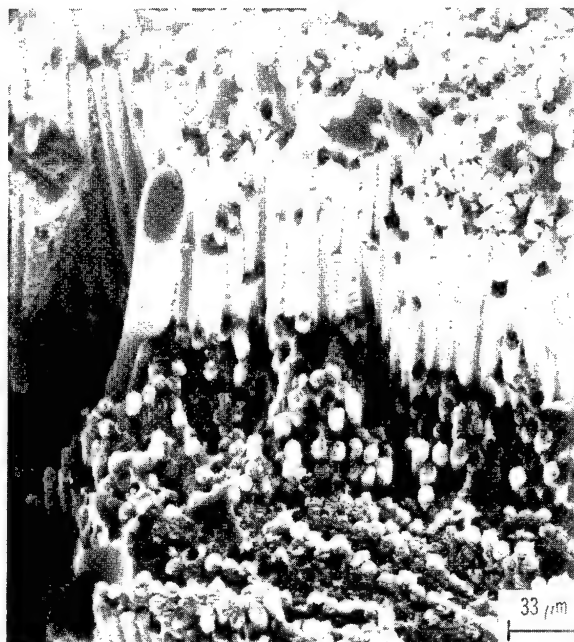
The fracture surface of the 5^0 off-axis tensile specimen (fig. 17) reveals the following features:

- (1) Surface tiering (fig. 17(b)) and matrix cleavage (fig. 17(c)) both of which are indicative of tensile fracture
- (2) Extensive matrix surface lacerations, indicating substantial fracture by intralaminar shear
- (3) Fiber pull-out and fiber surfaces free of matrix residue, indicating weak interfacial bonding.

Figure 17. - Scanning electron photomicrographs of fractured surface of Mod I/E composite tested at 5° to fiber direction.

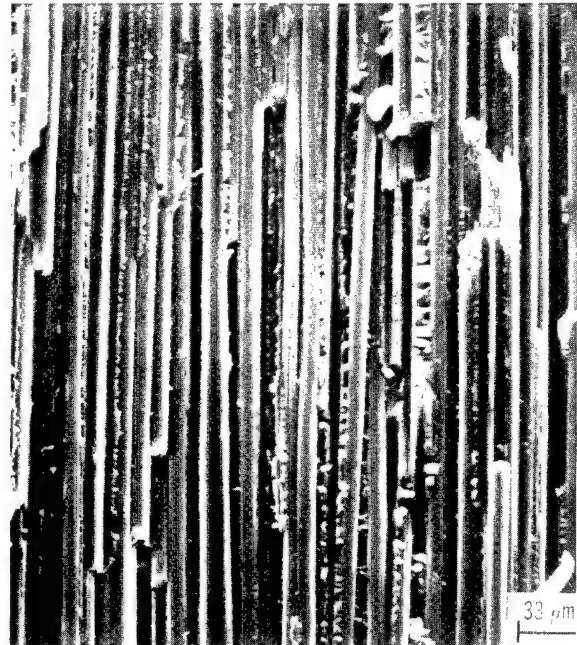
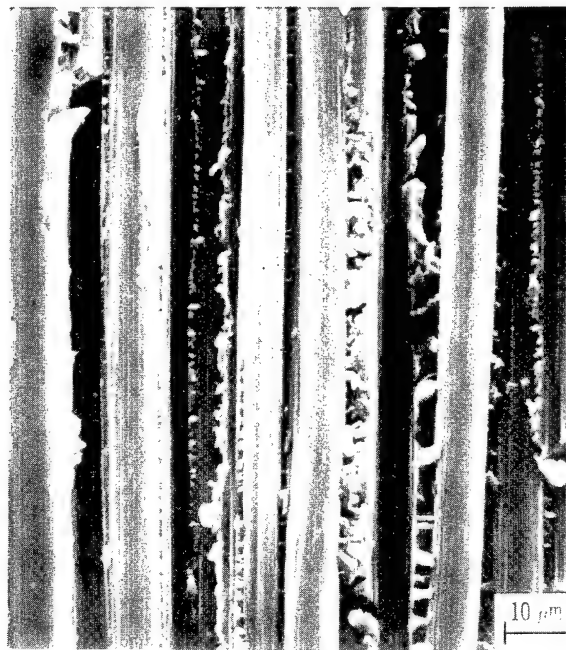
The fracture of the 10° off-axis tensile specimen (fig. 18) reveals (1) matrix surface lacerations and (2) fiber surfaces free of matrix residue. Both of these features indicate that a different fracture mode became active. We will consider this mode to be induced by intralaminar shear stress. It is this observation and the theoretical considerations to be described in Part II that led to the recommendation that the 10° off-axis tensile specimen is suitable for intralaminar shear characterization of unidirectional fiber composites.

Figure 18. - Scanning electron photomicrographs of fractured surface of Mod I/E composite tested at 10° to fiber direction.

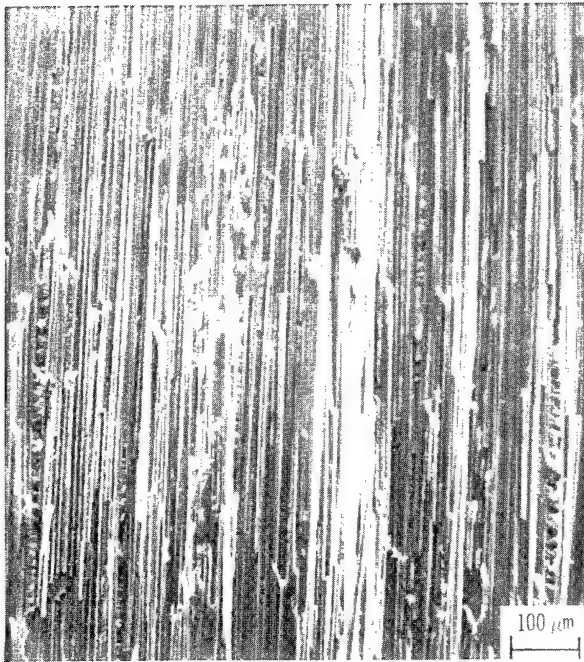
The fracture surfaces of the 15° and 30° off-axis tensile specimens (figs. 19 and 20) reveal similar features to those of the 10° off-axis tensile specimen. These surfaces, too, indicate that fracture was induced mainly by intralaminar shear stress.

Figure 19. - Scanning electron photomicrographs of fractured surface of Mod I/E composite tested at 15° to fiber direction.

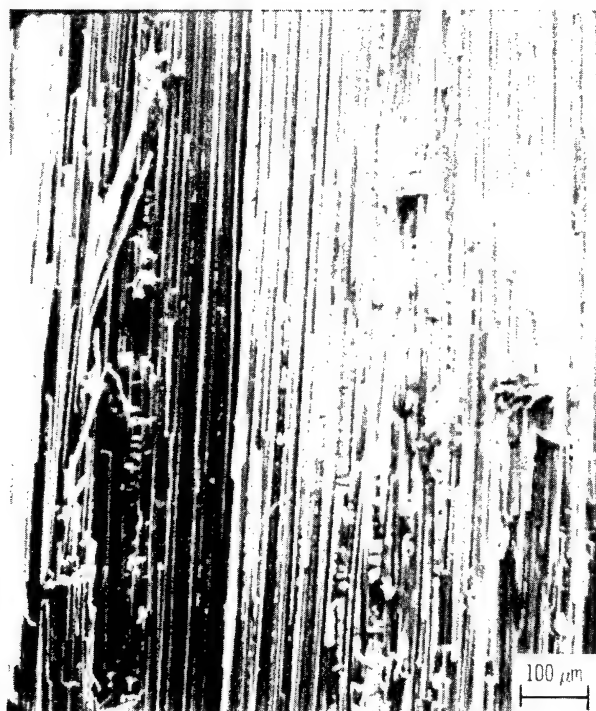
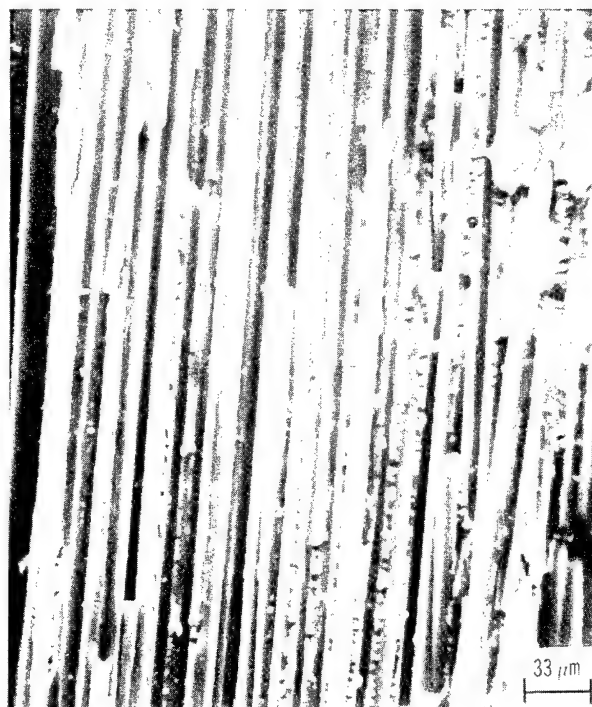
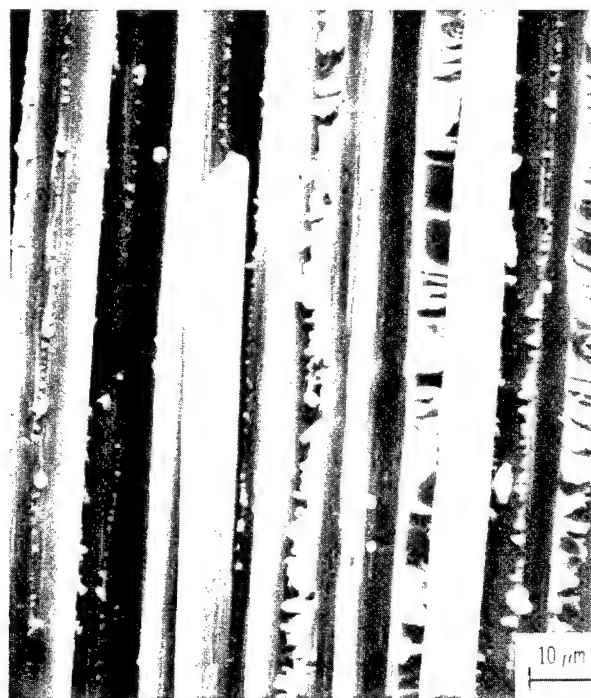
Figure 20. - Scanning electron photomicrographs of fractured surface of Mod I/E composite tested at 30° to fiber direction.

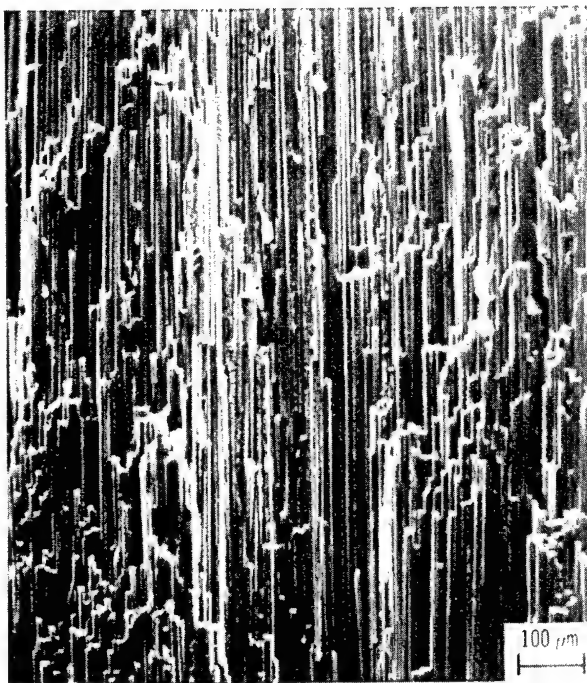
The fracture surface of the 45° off-axis specimen (fig. 21) reveals the following features:

- (1) Matrix cleavage with irregular boundary, indicating some transverse tensile fracture
- (2) Matrix debris resulting probably from tensile matrix fracture
- (3) Some matrix lacerations, indicating some intralaminar shear stress fracture.

These surface fracture features show that another fracture mode becomes active somewhere between a load angle of 30° and 45° . This mode is construed to have been induced by the transverse tensile stress.

Figure 21. - Scanning electron photomicrographs of fractured surface of Mod I/E composite tested at 45° to fiber direction.

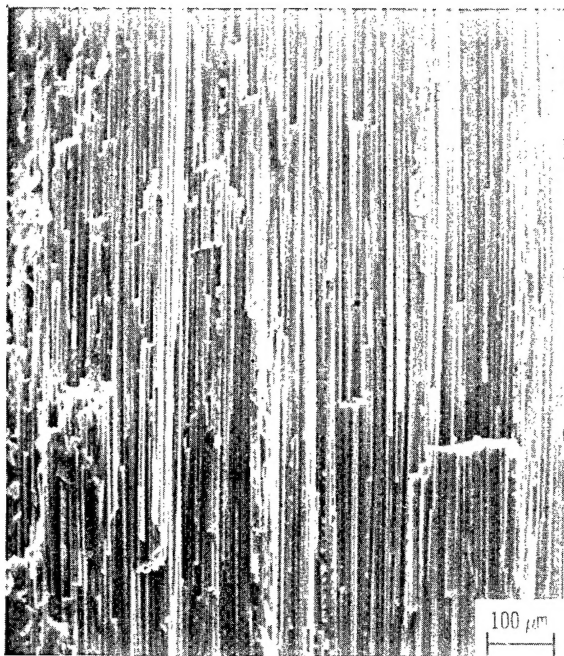
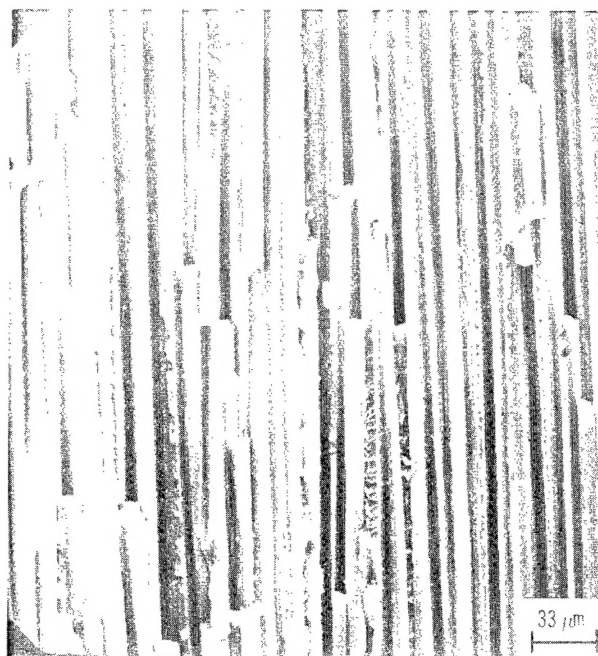
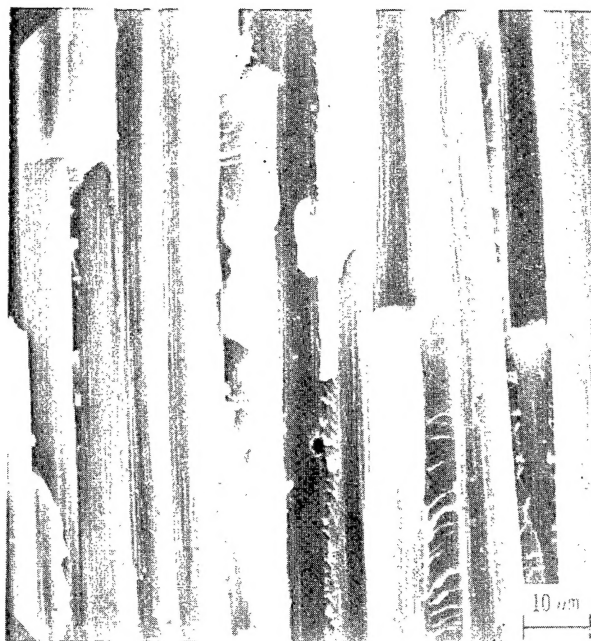
The fracture surfaces of the 60° off-axis tensile specimen (fig. 22) and the 75° specimen (fig. 23) reveal mainly matrix cleavage and some fiber surface free of matrix residue; both of these features indicate that fracture was induced by transverse tensile stress.

Figure 22. - Scanning electron photomicrographs of fractured surface of Mod I/E composite tested at 60° to fiber direction.

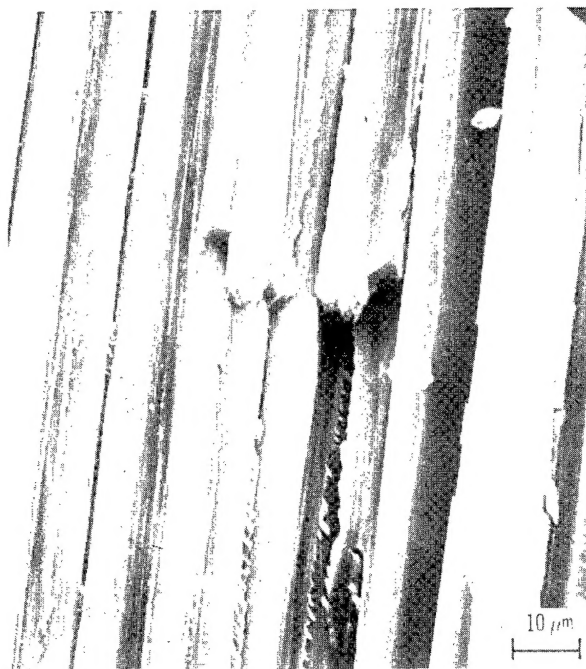
Figure 23. - Scanning electron photomicrographs of fractured surface of Mod I/E composite tested at 75° to fiber direction.

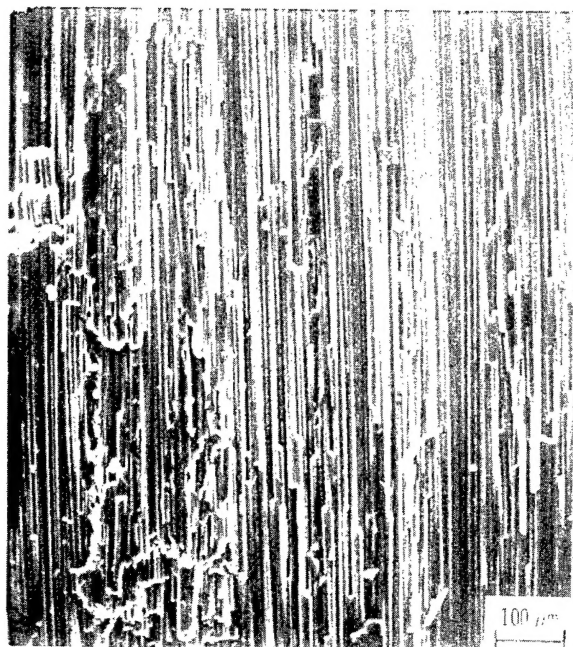
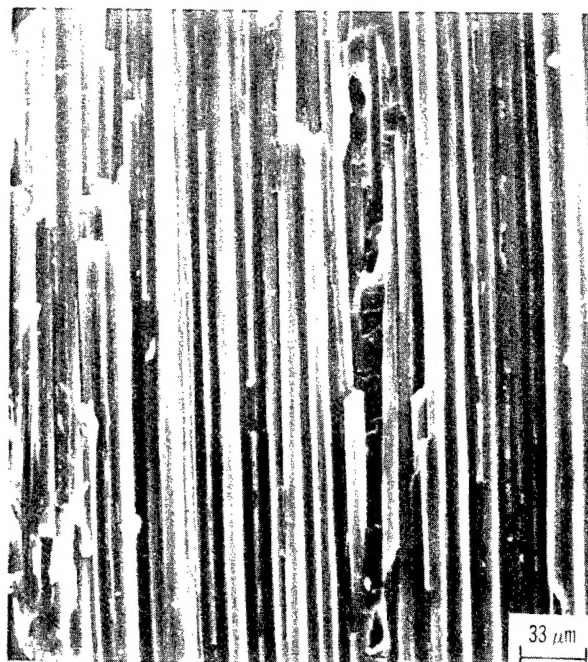
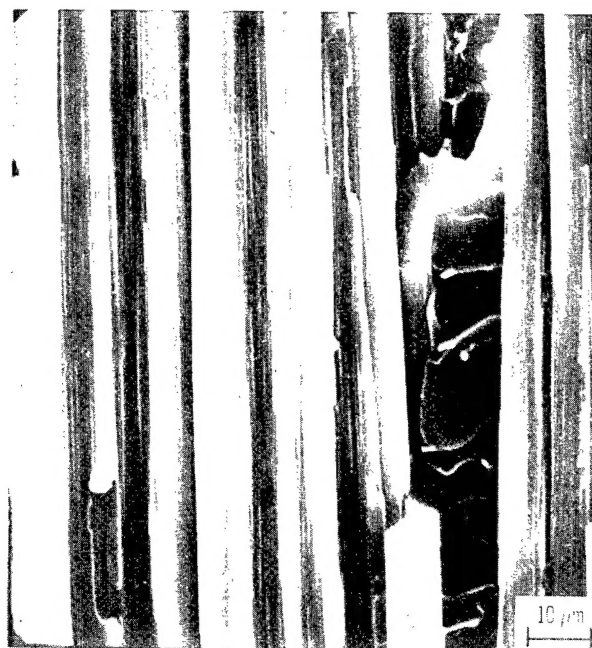
The fracture surface of the 90° tensile specimen (fig. 24) reveals the following features:

- (1) Matrix cleavage, indicative of tensile fracture of brittle materials
- (2) Fiber surfaces free of matrix residue, indicative of weak interfacial bond, as was already mentioned
- (3) Some matrix lacerations, indicating shear fracture at surfaces connecting two different levels.

These features indicate that transverse tensile stress produces fracture surfaces characterized by (1) matrix cleavage and (2) fiber surfaces clear of matrix residue.

Figure 24. - Scanning electron photomicrographs of fractured surface of Mod I/E composite tested transverse to fiber direction.
